EVALUATION OF STRUCTURAL ELEMENTS AND MODELING OF ÇARDAK KHAN^{1*}

Esra ŞAHİN¹

ABSTRACT

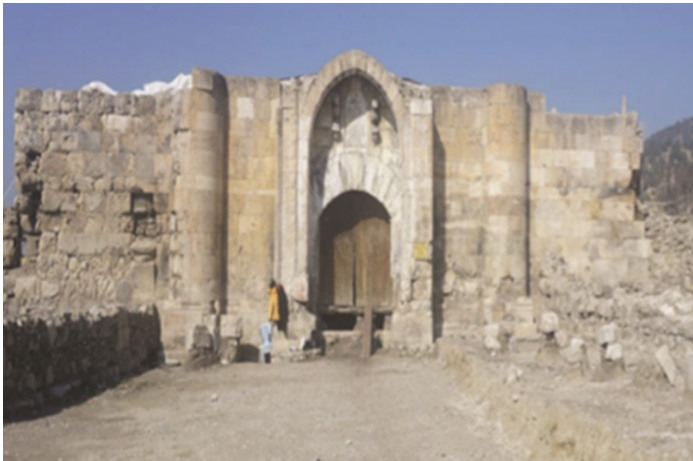
Figure 1: Çardak Khan

The monument located in the east-west direction is formed a rectangular courtyard (32.27 m in length, 31.16 m in width) with building ruins and a prismatic shelter (29.23 m in length, 26 m in height) entered from the courtyard as shown in figure 1. The northern part of the courtyard is in ruins. These parts consist of various functions such as the bath, kitchen, storage, workshop, staff room and iwan. The shelter to the west of the courtyard is a vaulted building consisting of a single space. The length and weight of the shelter are 29.23 m. and 26 m., respectively. There are five barrel-vaulted galleries in the east-west direction. In addition, there are pierced walls separating the central walls. The height of the central gallery is 5.40 m. The vaults, which are 4.60 m high, descend from the center to the sides. Remains of low walls made of non-bearing walls also belong to the original platforms to accommodate people and belongings. The small ventilation holes in the vaults allow light to enter the shelter. The only opening at ground level is the portal. There are circular buttresses on both sides of the portal. Other buttresses have triangular and polygonal shapes. These buttresses ensure that the caravanserai is equally supported from both sides. Also, the caravanserai has a terrace. There is a staircase made of cut stone on the southeast side that enables access to this terrace [3,4].

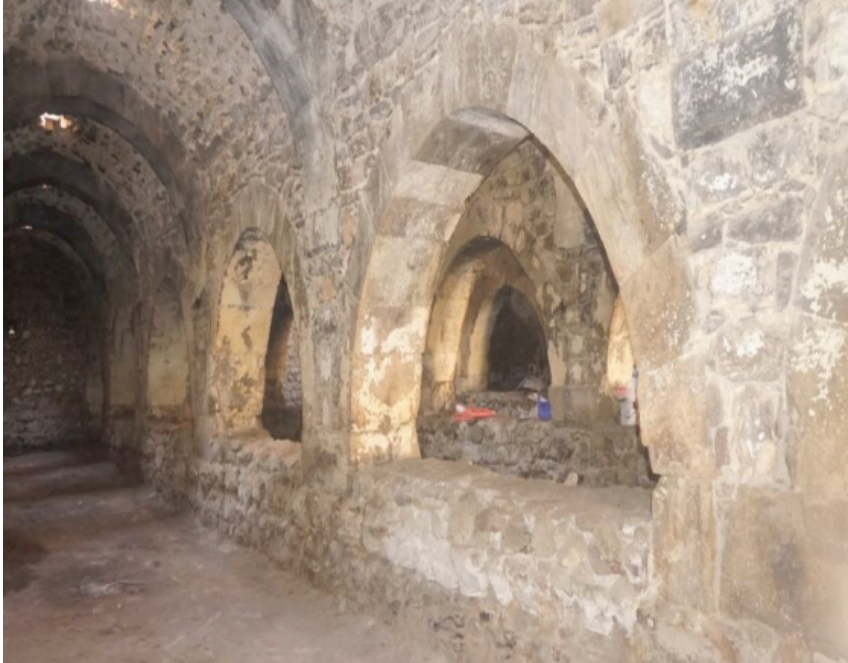
Figure 2: Superstructure Elements as Viewed from The West

Superstructural elements consist of vaults, arches, the squinch remain and a concrete slab as shown in figure 2. The barrel vaults of the shelter are located in east-west direction as shown in figure 3. The spanning distance at the center is 4.50 m, while it diminishes to 3.58 m and 1.97 m in the vaults at its north, and 3.06 m and 1.50 m in the vaults its south, respectively. Their heights are 3.10 m, 3.11 m, 3.37 m, 3.14 m and 2.98 m respectively from the north to the south. Their profiles are double centered and pointed as shown in figure 4. They are out of rubble stone put together with lime mortar. At their exterior, earthen finishing is observed. There are ventilation holes along the keystones of the vaults. Just under the springing line of the vaults, the construction holes are still observable [3].

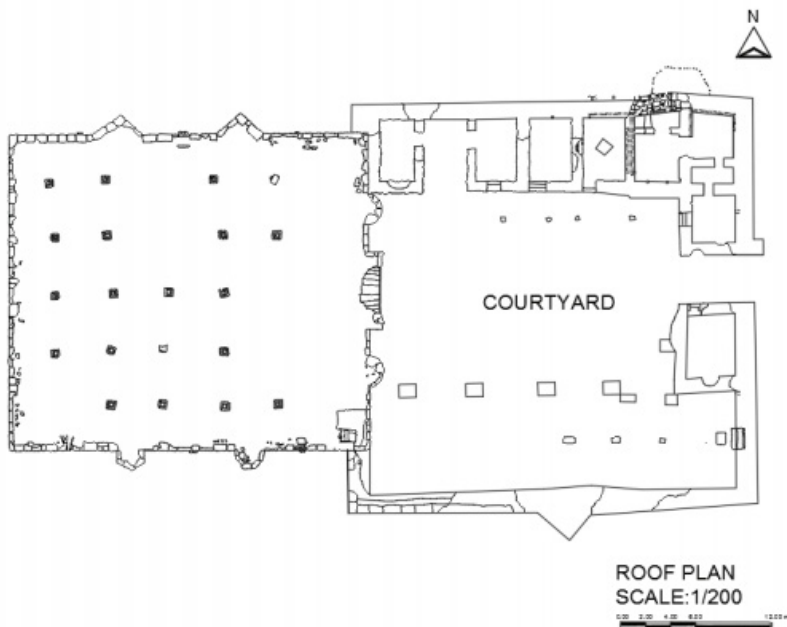
Figure 3: Roof Plan [5]

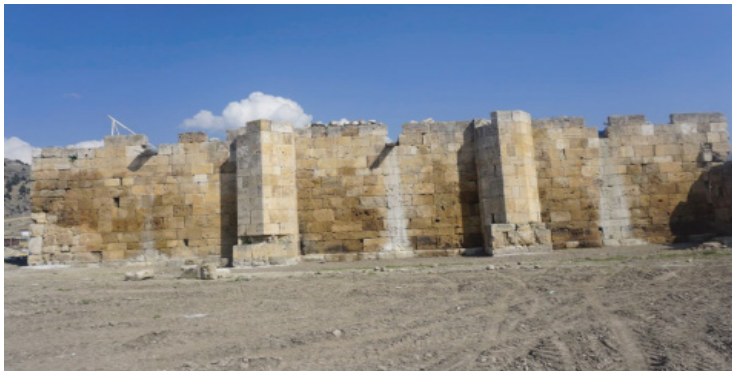
Figure 6: Interior Load Bearing Wall from Its Southeast

The interior load bearing wall of the shelter in figure 6, which are pierced with arches, are cut stone at their both surfaces. Their sections are unobserved. Their widths are 85 cm and 87.5 cm from the north to the south. The surfaces facing the central gallery are decorated with pilasters and animal figures. The non-load bearing walls at the interior belong to the original platforms for resting of people. At present, they define two u forms at the second and fourth galleries from the north to the south. They are single layered and out of rubble stone and lime mortar. Their widths are the same as the related load bearing wall. As the construction joints reveal, the service spaces around the courtyard were constructed after the completion of the shelter walls. Nevertheless, their techniques are very similar. Thus, there is not a period difference. The load-bearing exterior walls of the

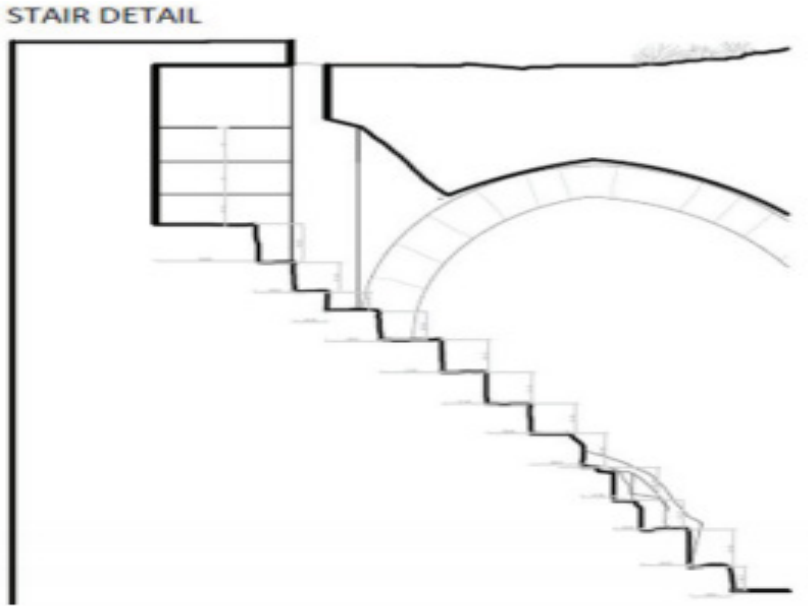
Figure 7: Stair Detail [5]

The ground of the shelter is screed at present. As the sampling excavations reveal, original rubble stone and compacted earth are present underneath the intervention layer as seen in figure 7. The courtyard is covered with debris in general. The staircase in figure 7 at the southeast corner of the shelter links the interior to the terrace roof. It is L formed; the lower portion is parallel to the eastern wall (width 35 cm, length 1.05 m), the upper portion is parallel to the southern wall (width 32 cm, length 1.25 m). The stairs are out of cut stone block, each approximately 30 cm in height [3].

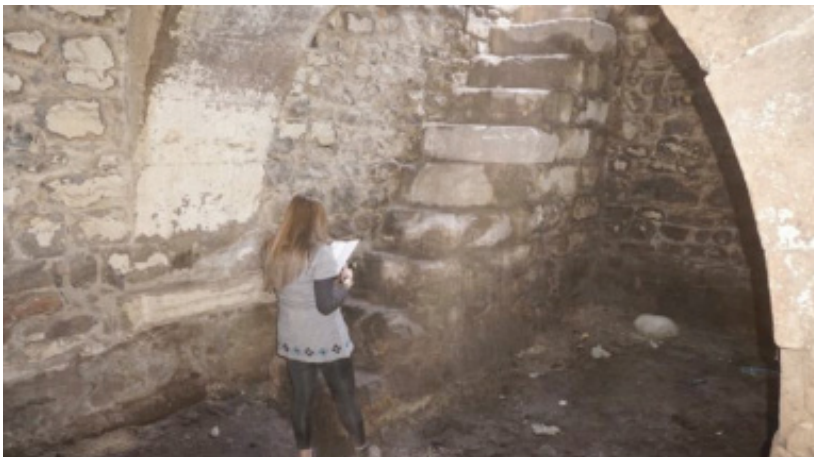
Figure 8: The Staircase

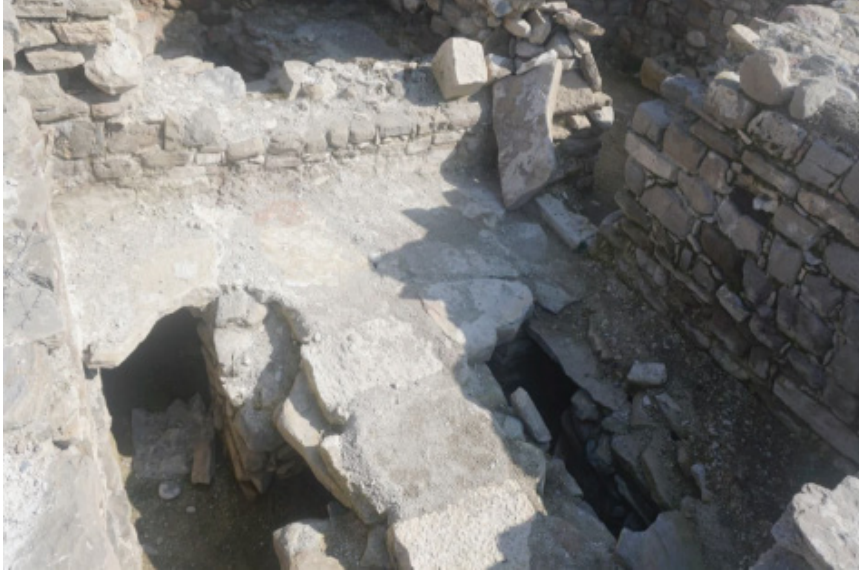
Figure 9: The Foundations at The North

As the sampling excavations reveal, the foundations continue underneath the interior walls (non-load bearing walls) of the shelter and the interior walls of the service spaces as shown in figure 8. They are out of rubble stone [3].

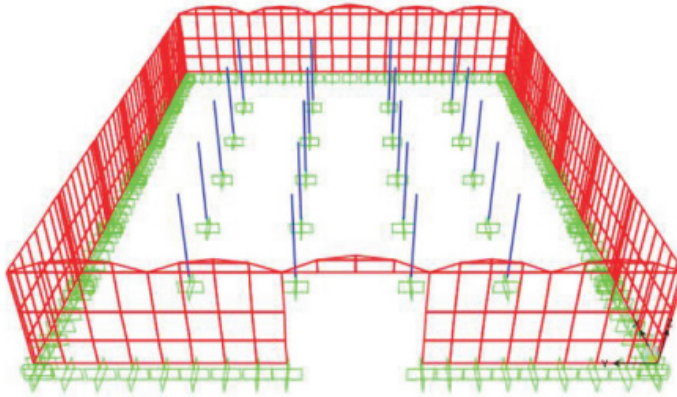
Figure 10: View of Columns and External Walls of The Khan

The architectural plans and sections of the caravanserai were drawn in AutoCAD format [5]. Three-dimensional model was developed according to this format and SAP2000 version 20.2 was used for modeling the masonry structure as seen in figure 9-13.

Frame and shell elements are used for the finite element model. While the frame element is suitable for the use of columns, shell elements are used in other elements such as dome, wall, vault, arch. The shell elements are divided into finite elements (mesh) to match boundary conditions. It was applied with the maximum unit side length of each partition

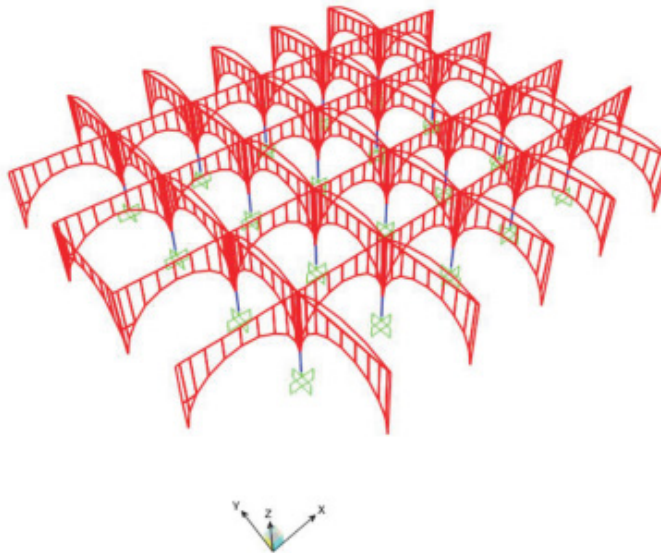
Figure 11: The Model without External Walls and Roof

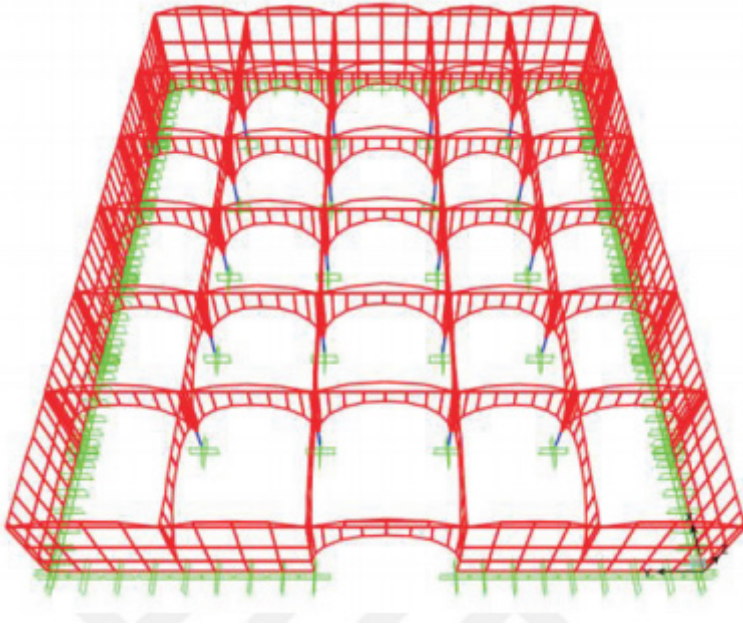
Figure 12: The Model without Roof

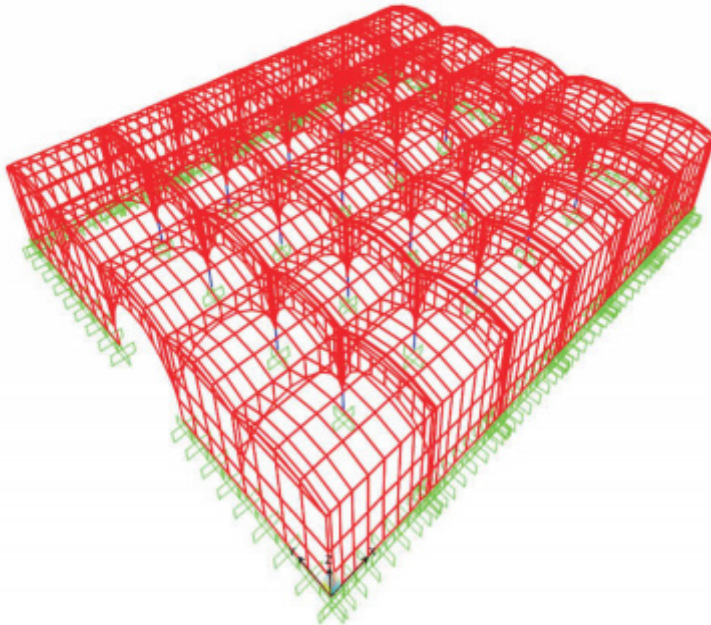
Figure 13: Shell and Frame Model

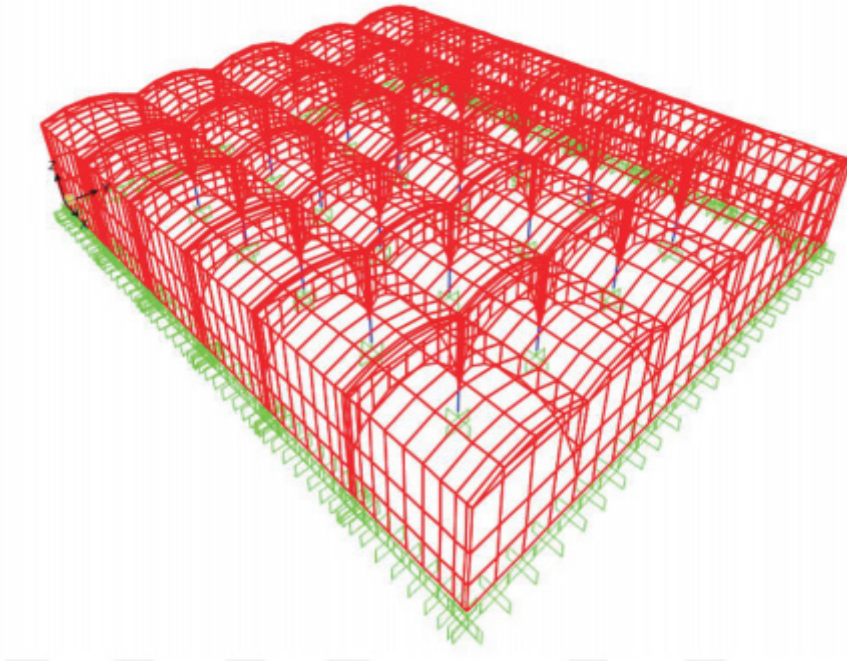
Figure 14: Back View of Shell and Frame Model
